# CRASH INJURY EVALUATION

U. S. ARMY YHU-1D

BELL IROQUOIS HELICOPTER MOCKUP

REPORT OF CRASH INJURY EVALUATION

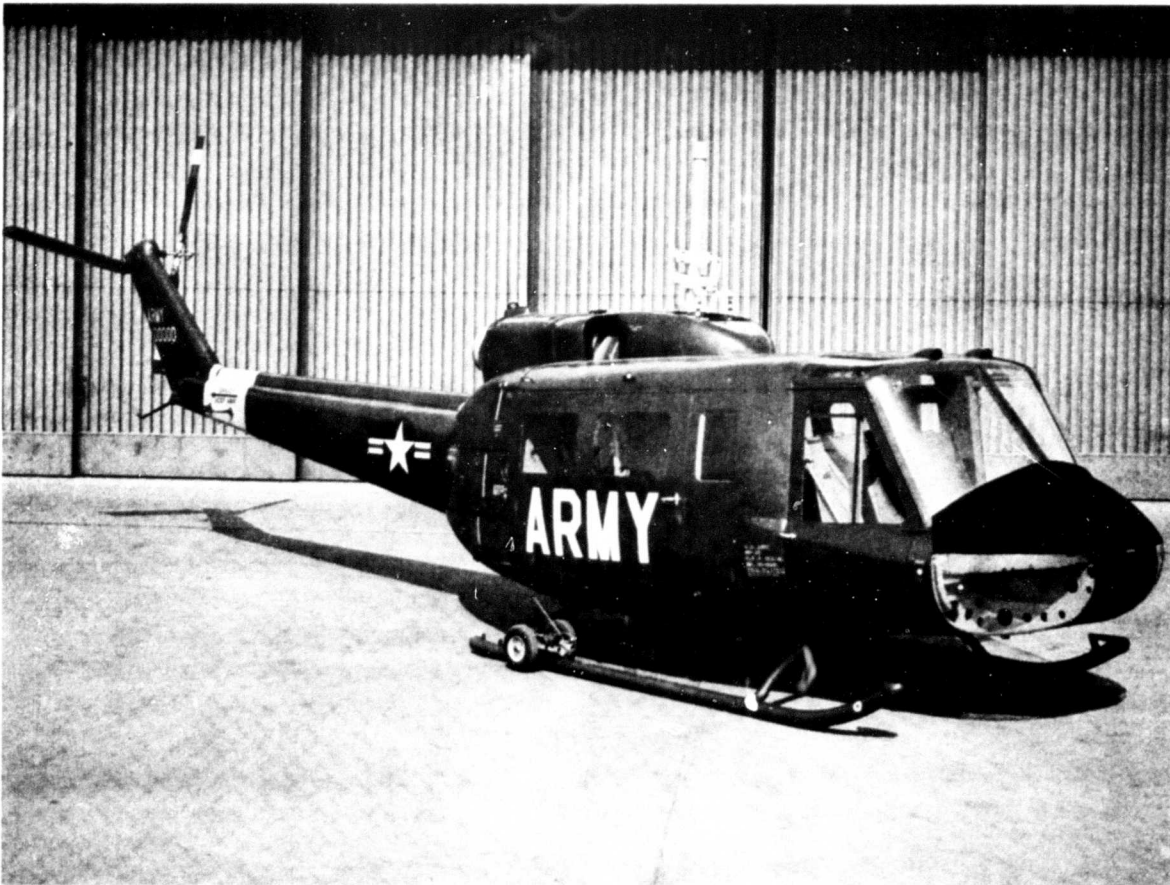
The YHU-1D (Figure 1) is a single rotor helicopter powered by a Lycoming T53-L-9 turbine engine of 1100 horsepower. The helicopter is designed for a cruise speed of 100 knots, maximum speed 129 knots. Its gross weight varies from 6588 to 8600 pounds, depending upon the mission.

Figure 1. Bell YHU-1D U. S. Army helicopter mockup

While the two front crew doors (Figure 1) are non-jettisonable, classic failure of the forward hinges in HU-1A accidents allows these doors to be thrown clear during moderate accelerations. Although roof and door frame distortions in the HU-1A accidents may have contributed toward "popping out" these doors, they do not seem to present any serious hazards with regard to emergency escape. Should the helicopter roll onto its side during an accident, it may be desirable to have kick-out provisions in the overhead windows.

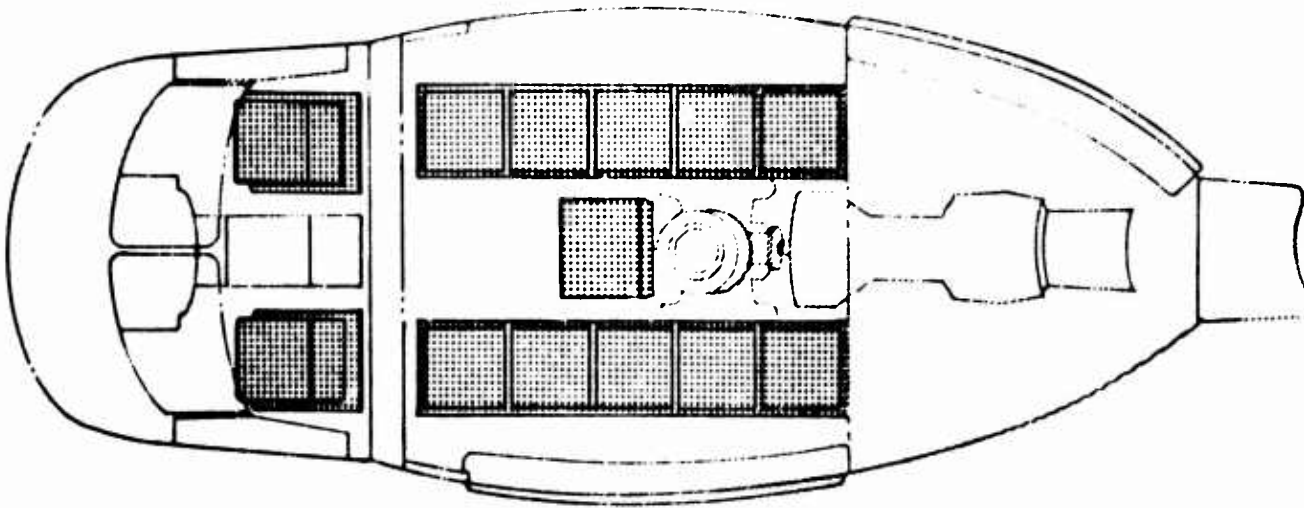
Figure 2. YHU-1D proposed seating arrangement

While emergency exit provisions in the basic aircraft appear to be adequate in size, number, and location, a serious problem is presented for the center seat occupant (forward of the pylon) if the seating configuration illustrated in Figures 2 and 23 is utilized. Evacuation would be even more critical should the aircraft come to rest on its side after an impact, in which case the troop seat occupants on the "low side" would also be in a very difficult position from which to emerge. For these reasons, the alternate configuration (Figures 3 and 25) is recommended.

4. The seating configuration shown in Figure 3 be utilized in preference to the proposed seating arrangement illustrated in Figure 2.
5. Crew seats, medical attendant seats, troop seats, and litter installations be dynamically tested to provide data which can be used as a basis for recommending changes to existing Military Specifications and structural design criteria.

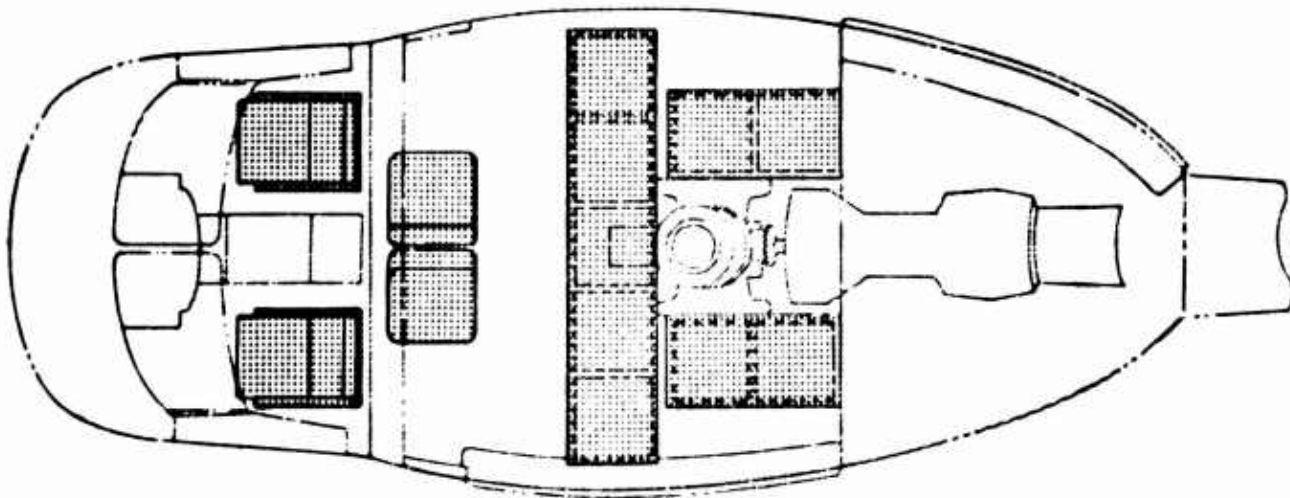
Figure 3. YHU-1D alternate seating arrangement

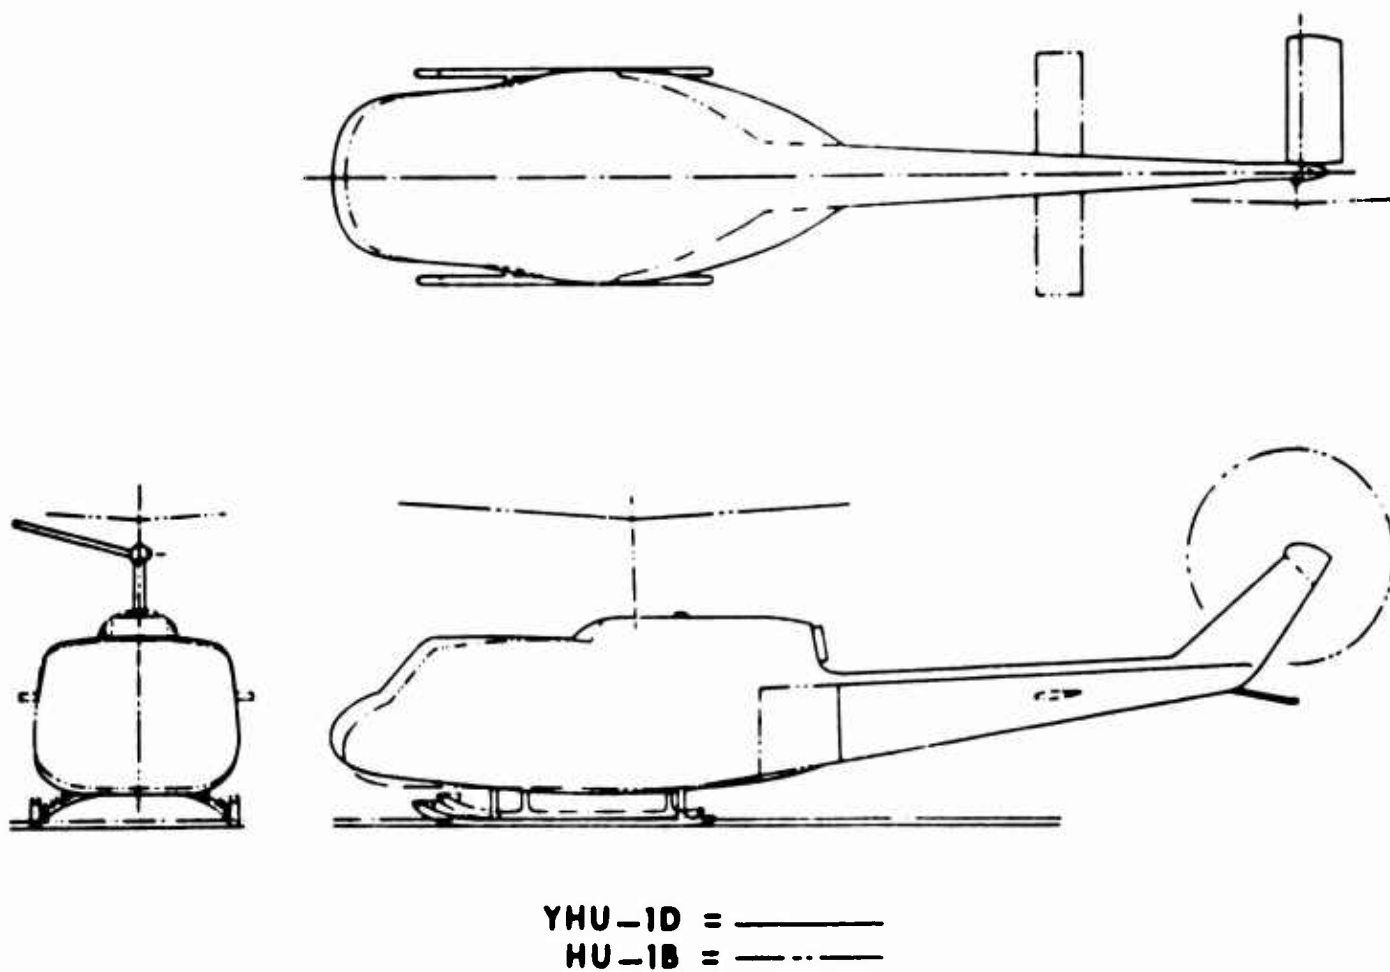
The YHU-1D is the largest of the Iroquois series helicopters. Figure 4 illustrates the difference in size between this model and the HU-1B. Major design features and other significant characteristics of this helicopter are discussed in subsequent sections of this report.

Figure 4. HU-1B and YHU-1D size comparison

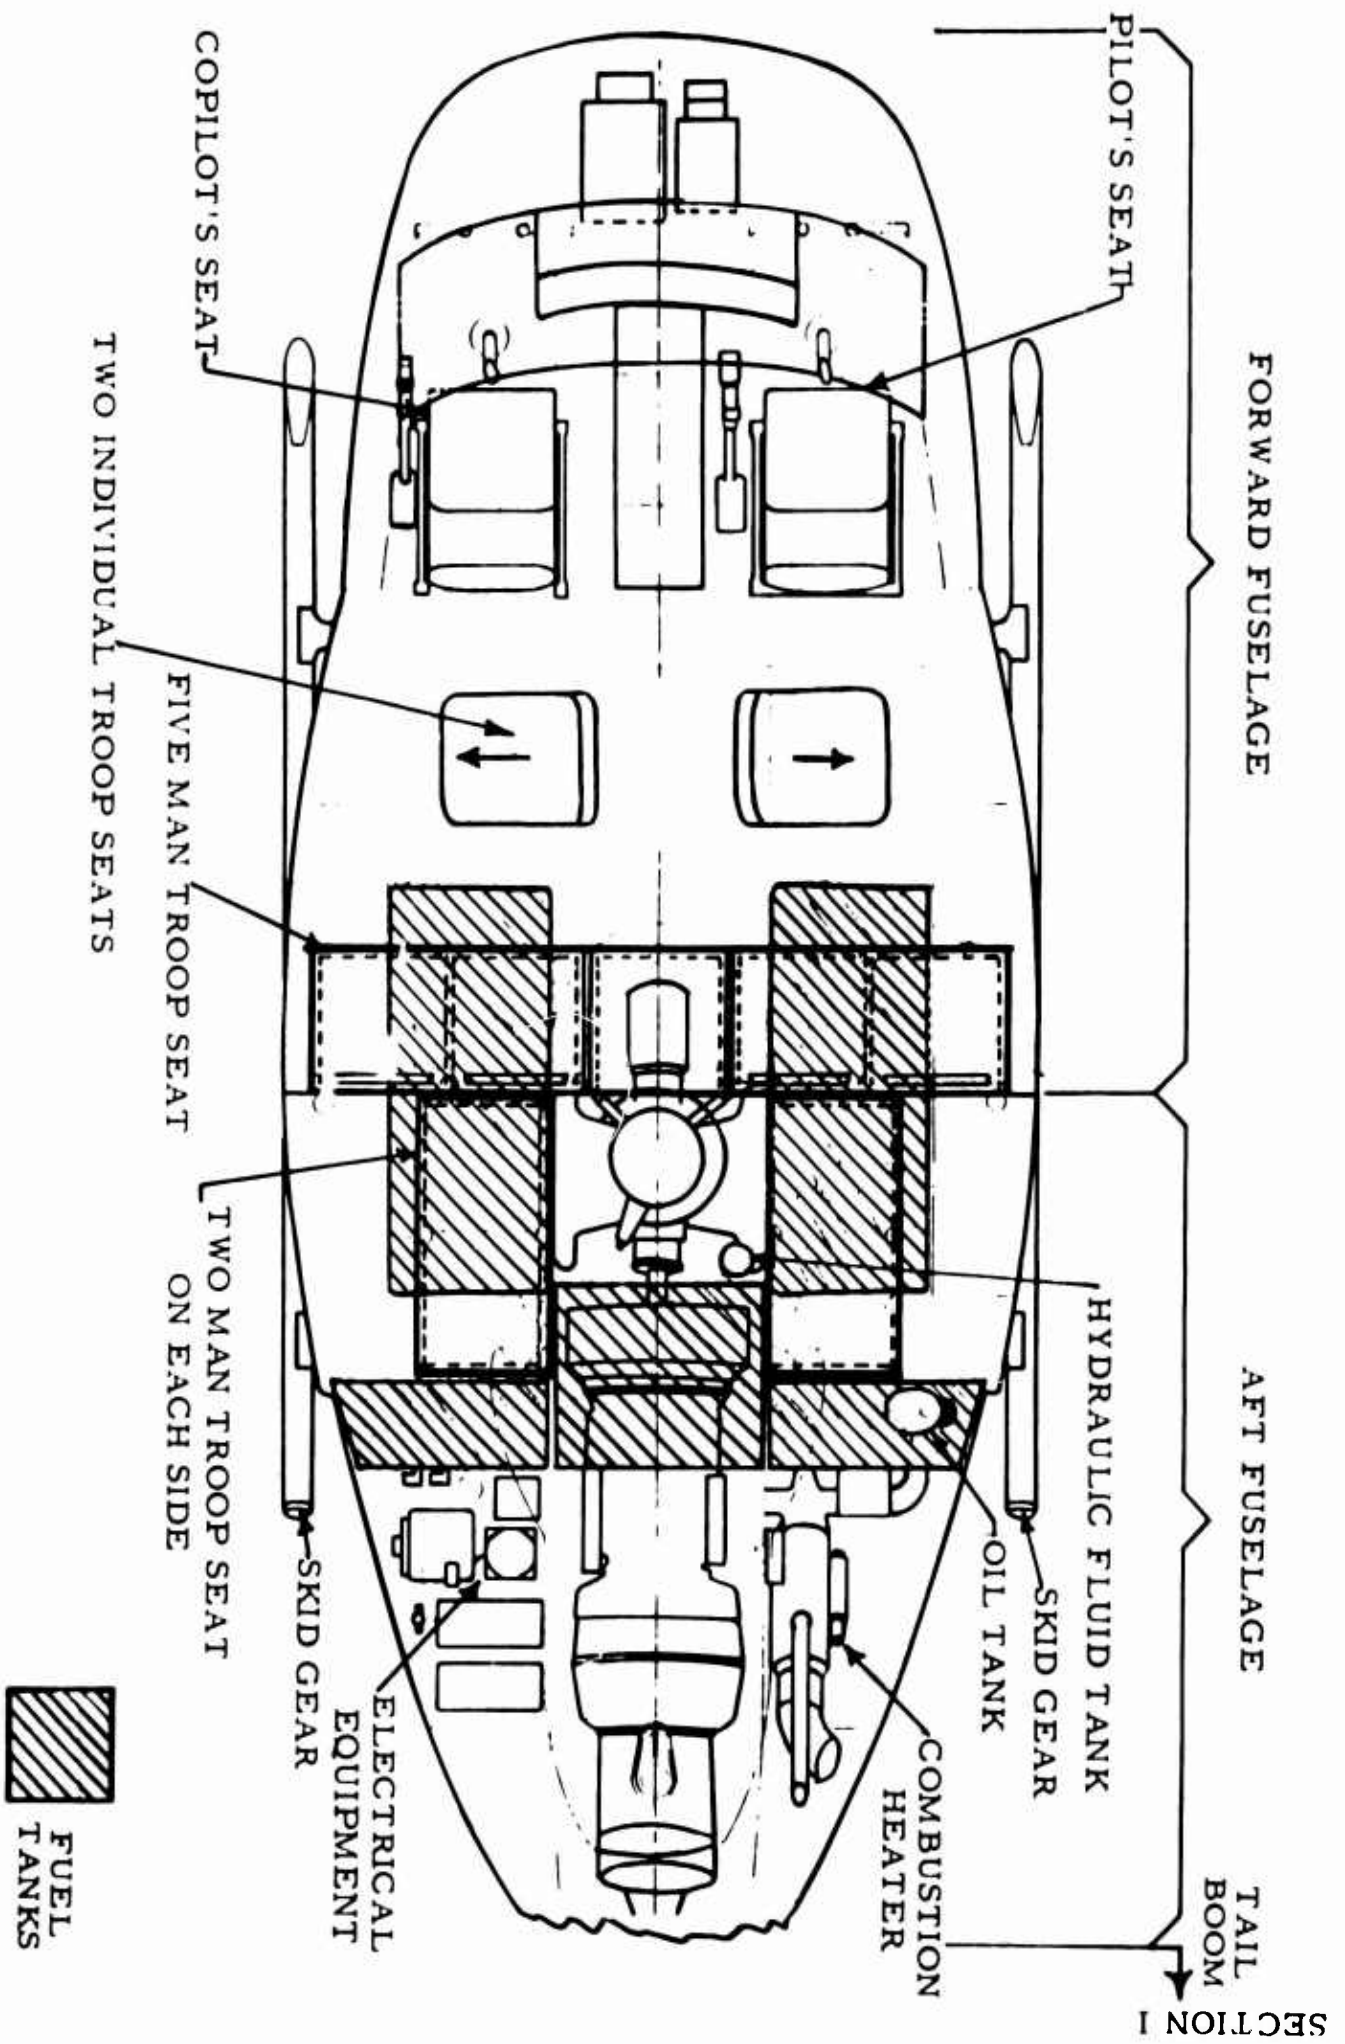
Two main parallel beams extend longitudinally fore and aft of the pylon and form the primary forward fuselage structure (Figure 5). These beams, together with adjacent structure, support an aluminum honeycomb deck, and their outer surfaces from Stations 102 to 155 provide support for the two forward fuselage fuel cells located beneath the cabin floor.

Figure 5. Top view of YHU-1D fuselage

The fuselage of the YHU-1D consists of two main sections: (a) The forward section, and (b) The aft or tail boom section. The forward section includes the landing gear, transmission, power plant, and crew and passenger locations (Figures 5 and 5A). The aft section supports the tail rotor and components and is attached to the forward section by means of four tension bolts.

The forward edge of the roof is attached to the lower fuselage through a center windshield post and two forward door posts (Figure 5). These, however, are not intended to carry any structural load, but serve only as front windshield frames and forward door posts.

The T53-L-9 engine is supported on the service deck of the aft fuselage at approximately Stations 166 to 215, between the fore and aft engine compartment firewalls (Figures 5, 5A, 19 and 20). The center 67-gallon fuel cell and the two 33-gallon outboard fuel cells are located beneath the service deck upon which the engine is mounted (Figure 10).

The proximity of the 100,000 BTJ/HR combustion heater to the right outboard 33-gallon fuel cell (Figures 5 and 22) may constitute a fire hazard in the event of a crash. Although the heater exhaust is deflected up and away from the tank area, flammable fuel mists coming in contact with hot exhaust surfaces could present a dangerous post-crash fire ignition source. Likewise, 'hot' electrical components on the left side, being in close proximity to the left outboard 33-gallon fuel cell, (Figures 11 and 20) may present similar potential hazards.

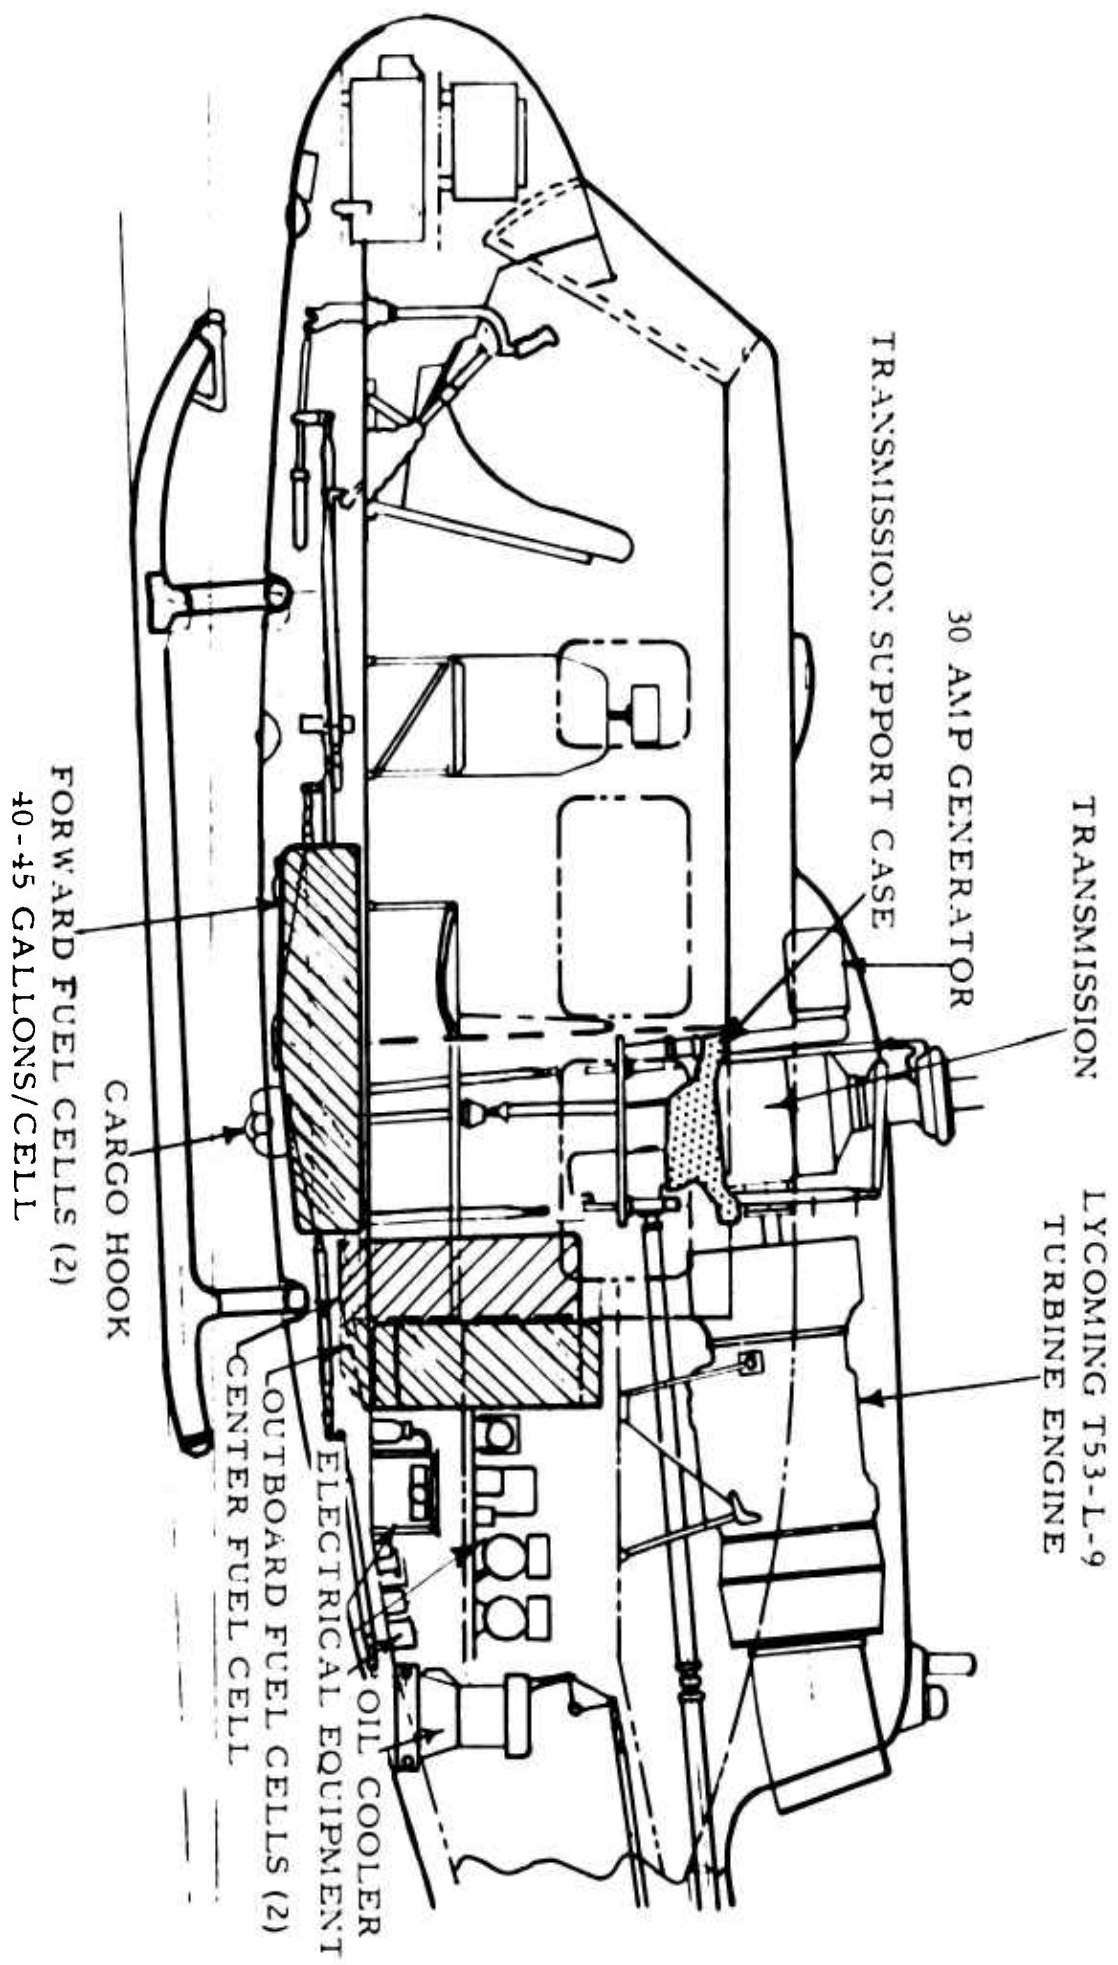
Figure 5A. Side view of YHU-1D fuselage

The cabin roof (Figure 5A) is supported at the aft end by aluminum honeycomb firewall on either side outboard of the pylon, and by attachment to the aluminum honeycomb on the left, right, and forward walls of the pylon. At the forward end, the roof is supported between Station 63.8 and 74.3 by a left and right door post. These door posts, or vertical support members, also provide a roll-over structure (Figure 7) through the roof and are designed for the following ultimate loads\* applied simultaneously:

The bottom of the under-floor tanks (Figure 5A) is designed for protection against impact rupture (or puncture by small rocks, branches, etc.) by a layer of approximately 2-1/2-inch aluminum honeycomb material. The top of the tank is approximately 1/2-inch aluminum honeycomb to which a crash-resistant fabric has been bonded. The basic structural design criteria for these outer beam tanks<sup>\*\*</sup> calls for the following ultimate load factors acting separately:

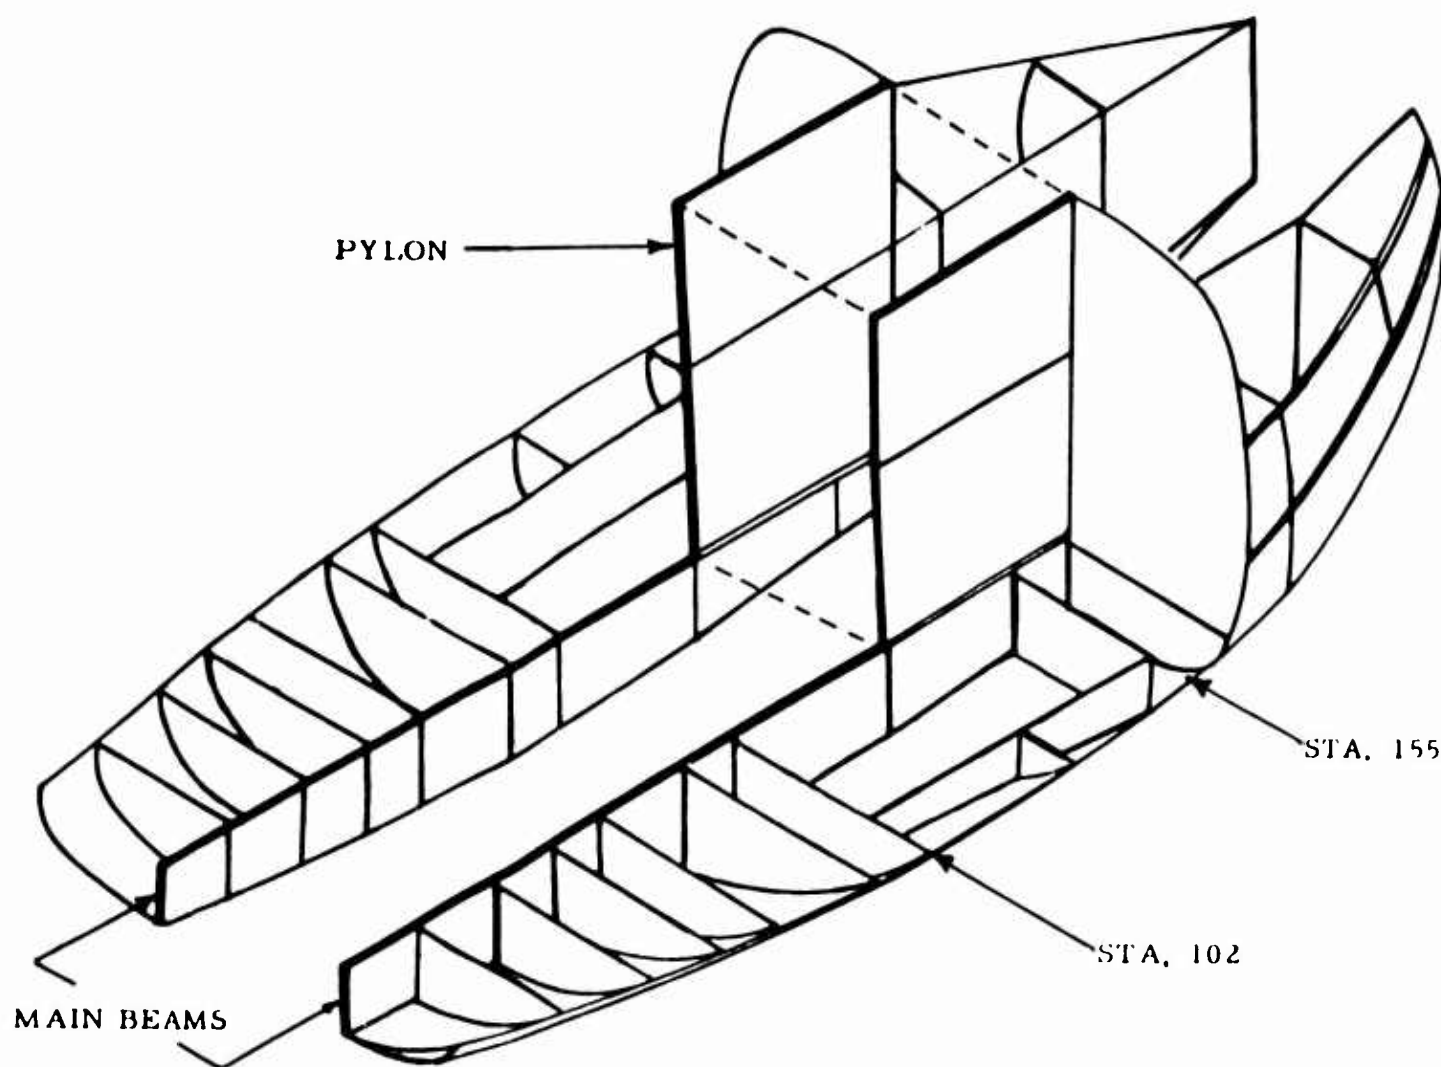
Figure 6. YHU-1D basic structure (fuselage)

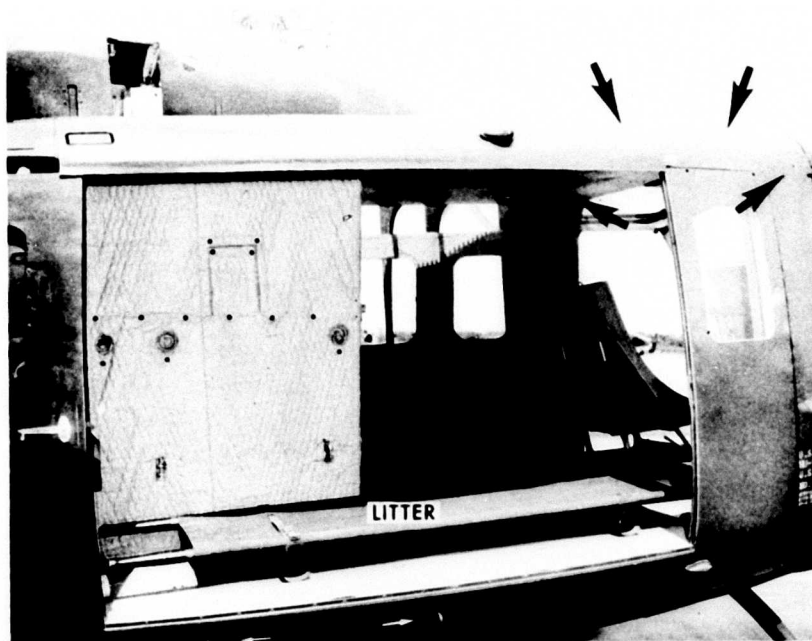
Figure 7. YHU-1D right side, main cabin. Note roll-over structure formed by vertical supports (carried through the roof structure).

These vertical supports have been critical failure points in the HU-1A models (Figure 8) and have since been strengthened in the HU-1B. The supports for the YHU-1D are considerably larger and stronger units. By comparison with the door posts in the earlier models, which were not designed to carry any structural loading, the vertical supports in the YHU-1D are now designed not only to carry structural loading, but also extend up to the roof beams through a radius in the upper attachments to form, in effect, a complete roll-over structure.

The YHU-1D roof supporting structures appear to be designed with considerable improvement; however, the dynamic response, or the structural integrity, of the larger, heavier roof and proportionately stronger supports cannot be predicted with any degree of accuracy without subjecting these units to full-scale dynamic testing. It appears desirable, therefore, to subject these structures, in their planned configuration and structural relationships, to dynamic testing under laboratory conditions.

- b. The dynamic response, structural integrity, and ability of the larger, heavier roof to resist failure or deformation into the occupiable area of the aircraft.

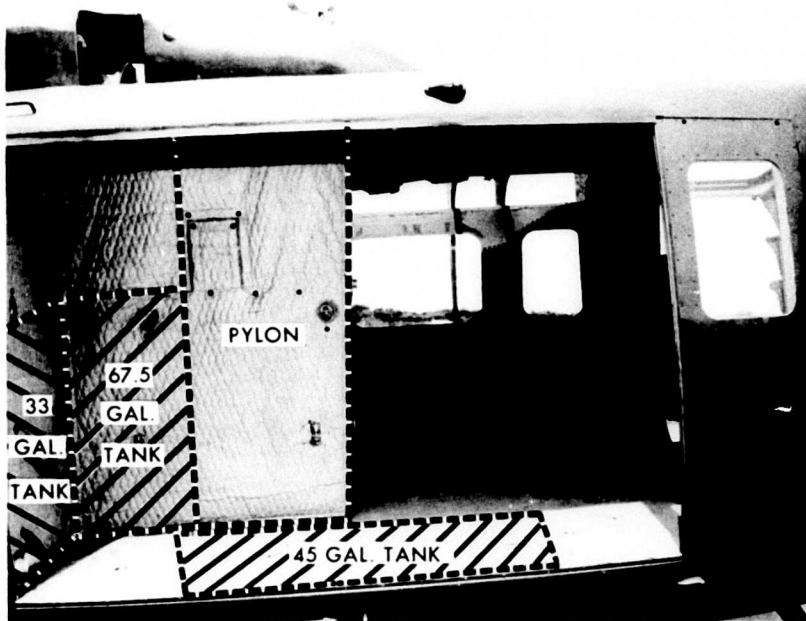
The walls of the pylon structure and aft bulkheads, including the upper firewall section of the aft cabin bulkheads, are constructed of aluminum honeycomb material (Figure 9). The aluminum honeycomb bulkheads at the aft end of the main cabin and the aft wall of the pylon provide wall surfaces for the one 67-gallon and two 33-gallon fuel tanks. The need for these bulkheads to resist tearing or puncture damage is obvious and will be discussed further in the following paragraph.

Figure 9. Relative location of fuel cells and pylon in main cabin

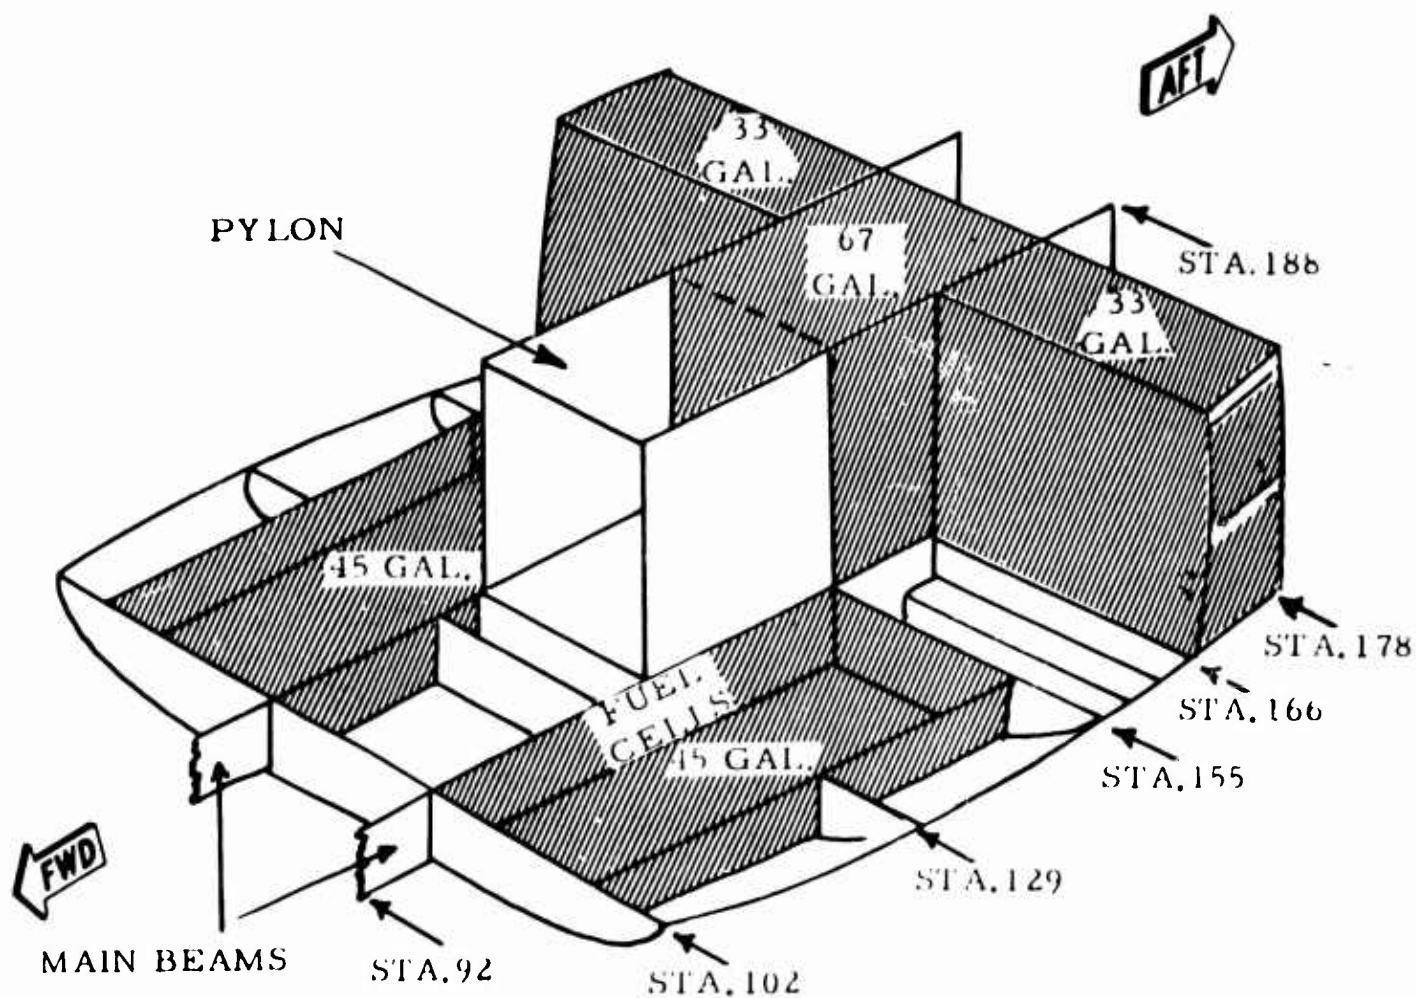
Figure 10. YHU-1D fuel cell arrangement

Due to the highly combustible nature of JP4 fuel<sup>\*</sup>, it is extremely important that the possibility of crash impact fuel cell rupture be prevented. Accident experience with the HU-1A helicopter has indicated that the aluminum honeycomb construction of fuel cells provides a good degree of impact protection against rupture and massive spilling. While post-crash fuel spillage or seepage has been noted in some of the HU-1A accidents, it has not generally been of such massive dispersment that potential fire ignition sources have come in contact with flammable fuel mist. With the redistribution of fuel cell location in the HU-1D, however, it would seem wise to carefully evaluate any new fuel spillage and post-crash fire hazards which may be introduced through such relocation, particularly with reference to fuel cells in the floor.

- c. The ability of fuel cells, installed as presently planned, to resist puncture or spillage under crash force conditions, thereby creating potential post-crash fire ignition sources.

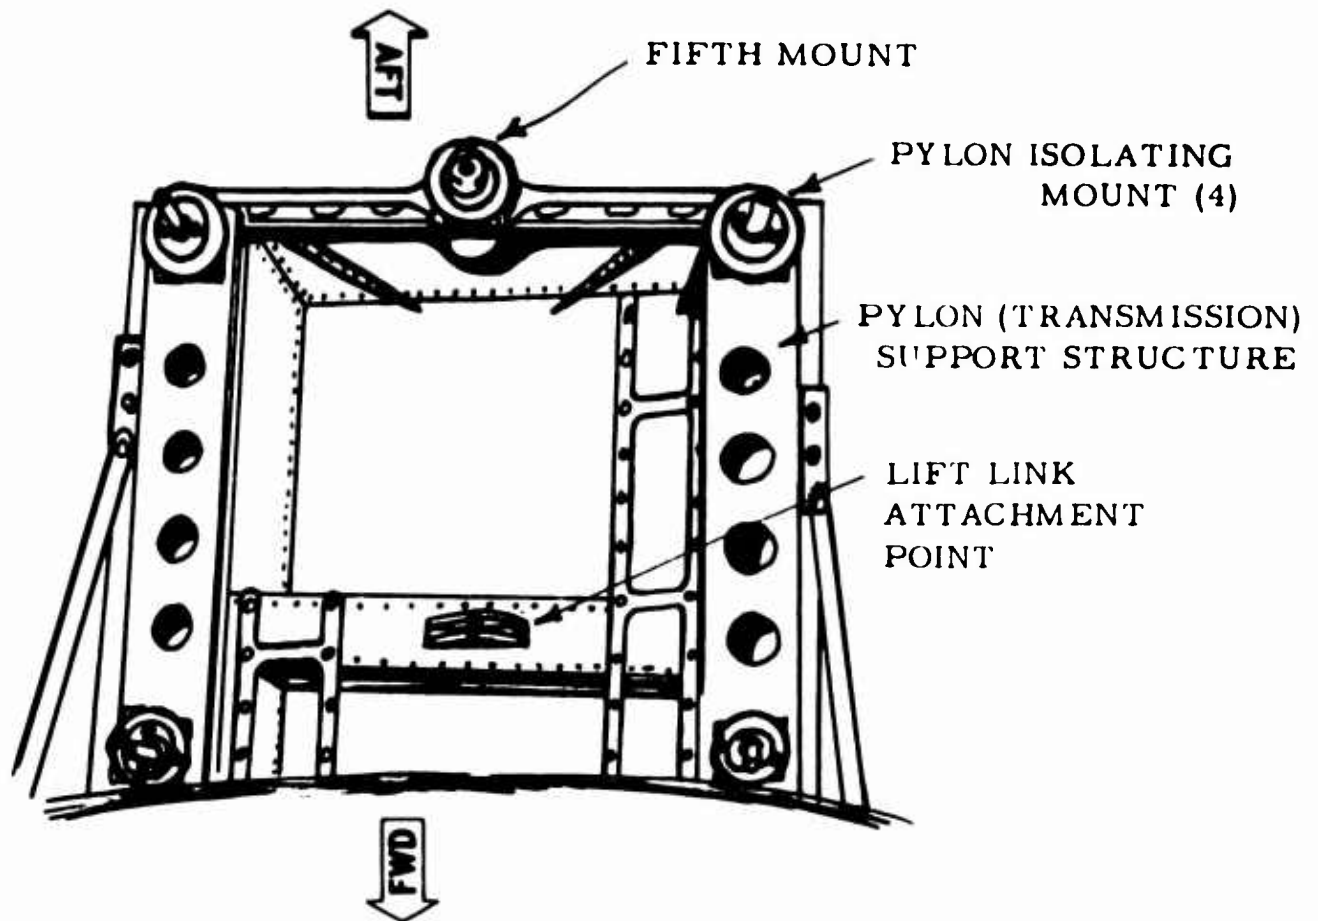
Figure 12. YHU-1D transmission support case mounts and support structure (top view)

In the YHU-1D, a greater mass must be supported by the same magnesium case because of the larger and heavier rotor system. It is questionable, therefore, whether the addition of the fifth mount will be effective in preventing failures such as experienced in the referenced HU-1A accidents. It appears that a solution to this problem would be to fabricate the transmission support case of welded ductile steel forgings, possibly stainless steel, which will yield progressively rather than shatter as in the case of the magnesium casting.

Addition of restraining cables attached to, or encircling, the transmission case and anchored to primary aft fuselage structure, also should be considered as a possible means of preventing the transmission group assembly from penetrating into the occupiable area when subjected to impact.

2. Consideration be given to replacement of the cast magnesium transmission support case with a newly designed type which would yield progressively rather than shatter. Consideration should be given to the use of materials such as ductile steel forgings, possibly stainless steel.

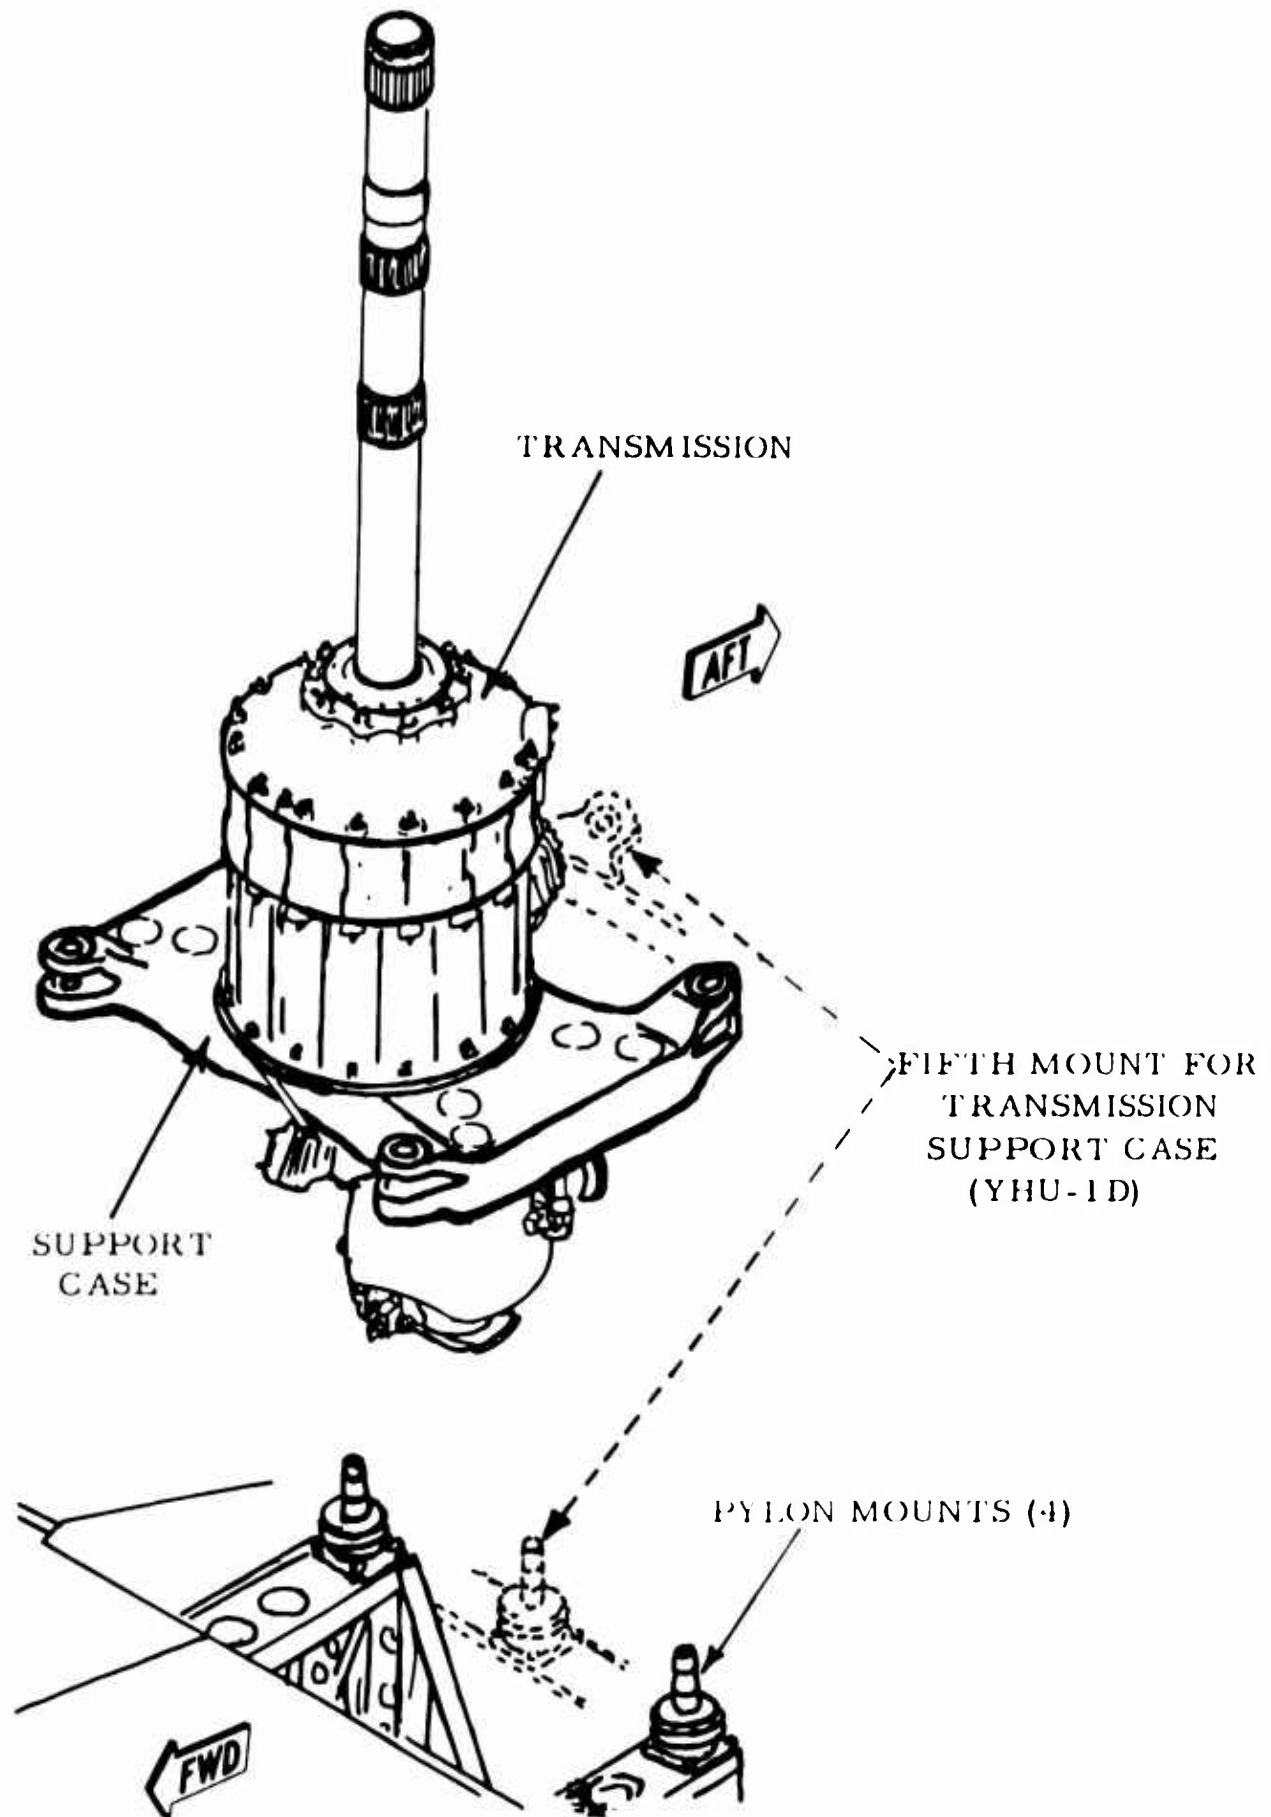
Figure 13. HU-1A mast, transmission support case, and pylon isolating (sprung) mounts

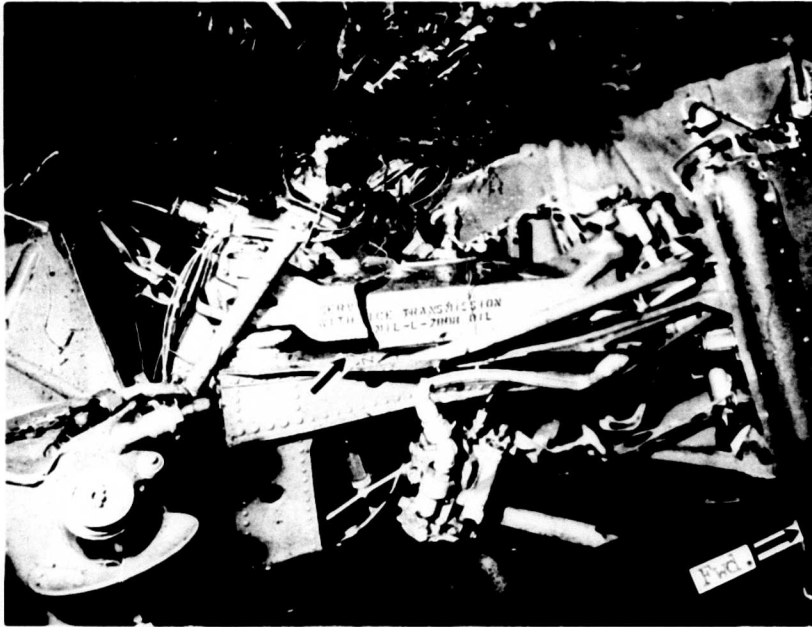
These repeated failures indicate an inherent weakness in the magnesium transmission support case.

Figure 14. Transmission support case failure, HU-1A accident, East St. Louis, Illinois, 21 October 1959

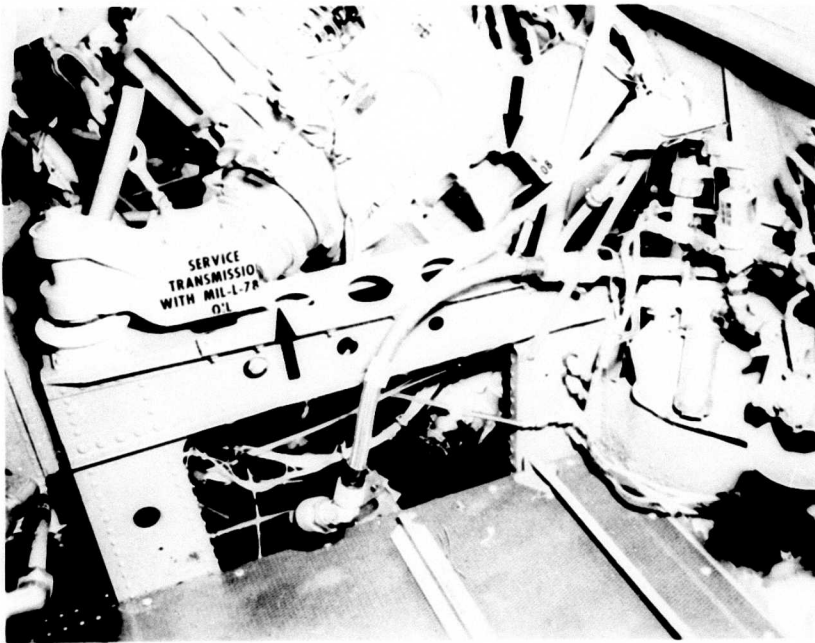
Figure 15. Transmission support case failure, HU-1A accident, Fort Carson, Colorado, 9 June 1960

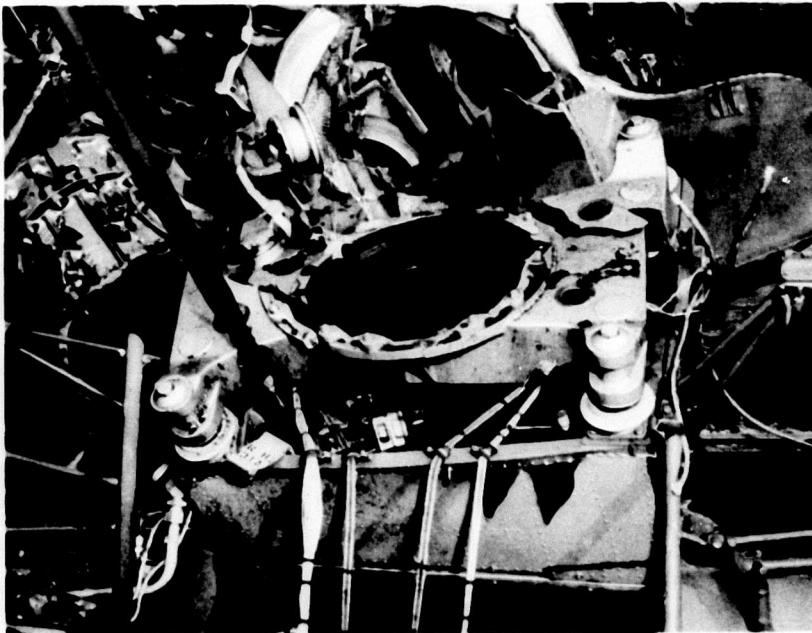
Figure 16. Transmission support case failure, HU-1A accident, Fort Bragg, North Carolina, 20 August 1960

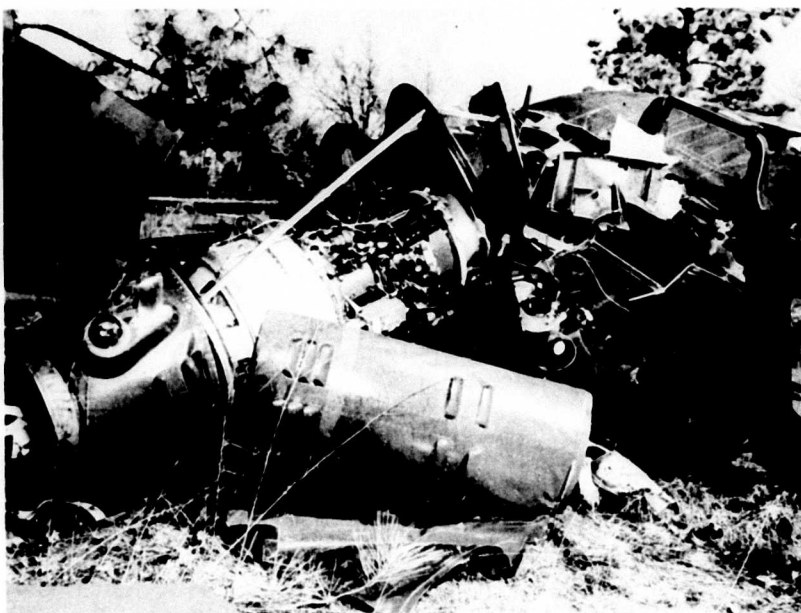
Figure 17. Transmission and support case failure, HU-1A accident, Fort Rucker, Alabama, 4 March 1960

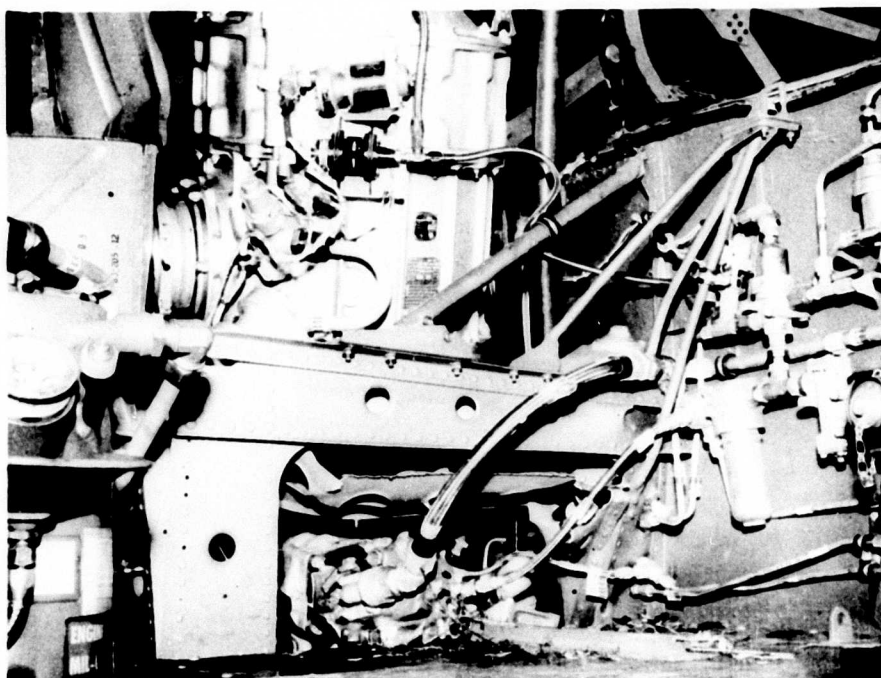
Figure 18. Transmission support case failure, HU-1A accident, Fort Rucker, Alabama, 26 August 1960

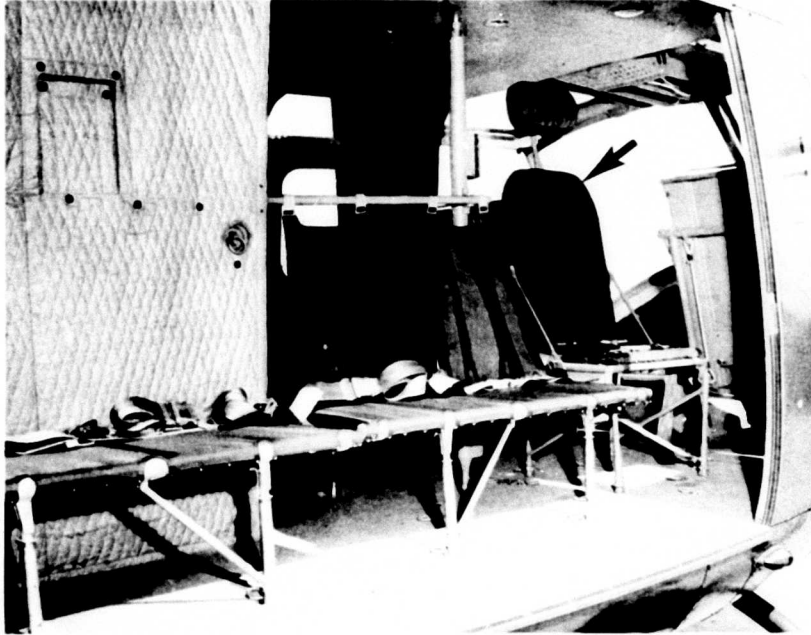
Figure 24. YHU-1D proposed troop seating configuration. Single seat (arrow) is essentially the same as the medical attendant's seat which is installed either forward or aft-facing in the center of the fuselage.

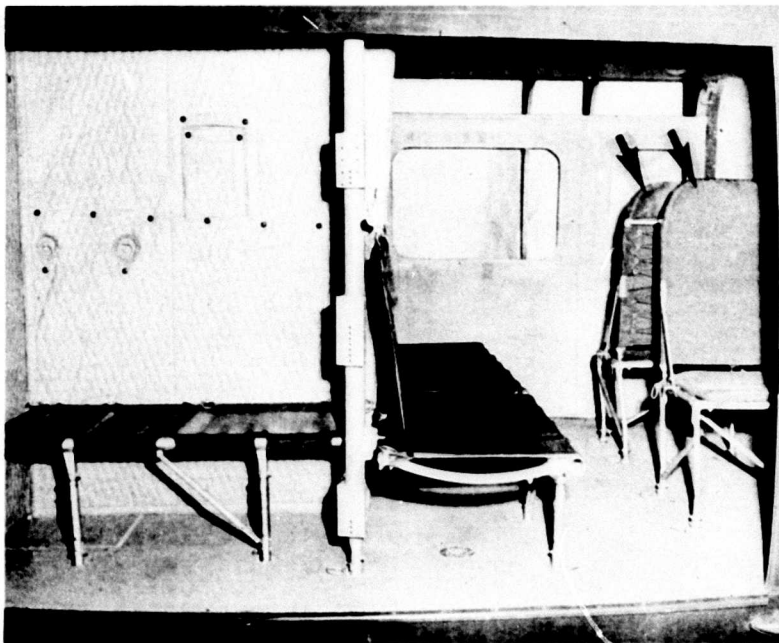
Figure 25. YHU-1D alternate troop seating configuration. Single troop seats (arrows) face outboard in this configuration.
